**CALIFORNIA GEOLOGICAL SURVEY  
FAULT EVALUATION REPORT FER 265**

**THE ROSE CANYON FAULT  
in the Point Loma and La Jolla 7.5 Minute Quadrangles  
San Diego County, California**

By  
Michael DeFrisco  
Engineering Geologist  
February 18, 2021

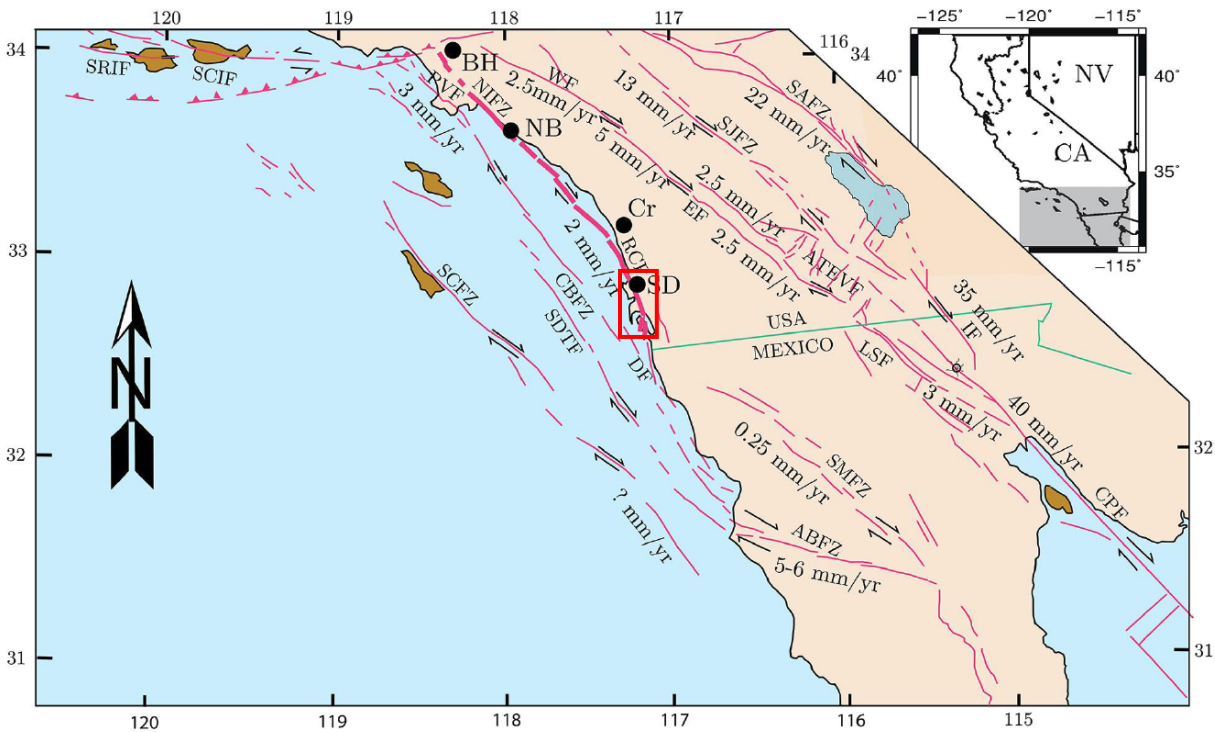
Figure 1. Active faults of southern California with their corresponding slip rates (modified from Singleton *et al.*, 2019). Shaded box in inset shows location in California. Red rectangle shows location of the La Jolla and Point Loma Quadrangles evaluated for this study and illustrated on Plate 1. The trace of the Newport-Inglewood-Rose Canyon Fault system is bolded. Circles are locations of urban centers: BH=Beverly Hills, NB=Newport Beach, Cr=Carlsbad, and SD=San Diego. SAFZ=San Andreas Fault zone, IF=Imperial Fault, SJFZ=San Jacinto Fault zone, EF=Elsinore Fault zone, CPF=Cerro Prieto Fault, LSF=Laguna Salada Fault zone, SMFZ=San Miguel Fault zone, ABFZ=Agua Blanca Fault zone, DF=Descanso Fault, RCF=Rose Canyon Fault zone, NIFZ=Newport-Inglewood Fault zone, PVF=Palos Verdes Fault zone, CBFZ=Coronado Bank Fault zone, SDTF=San Diego Trough Fault, SCFZ=San Clemente Fault zone, WF=Whittier Fault zone, SCIF=Santa Cruz Island Fault, and SRIF=Santa Rosa Island Fault.

The RCFZ is a dextral strike-slip fault that is part of the greater San Andreas Fault System which forms the plate boundary between the Pacific and North American tectonic plates and consists of several onshore and offshore northwest-trending right-lateral strike-slip faults (Figure 1). The Newport-Inglewood Fault Zone/RCFZ (NIFZ/RCFZ) is the easternmost fault system within the inner Continental Borderlands (ICB) offshore region of southern California and poses a significant seismic hazard to coastal southern California (Sahakian *et al.*, 2017). Geodetic measurements indicate that up to approximately 49 mm of right-lateral displacement occurs across the plate boundary annually (e.g. Bennett *et al.*, 1996). Approximately 84% (41 mm/yr) of displacement

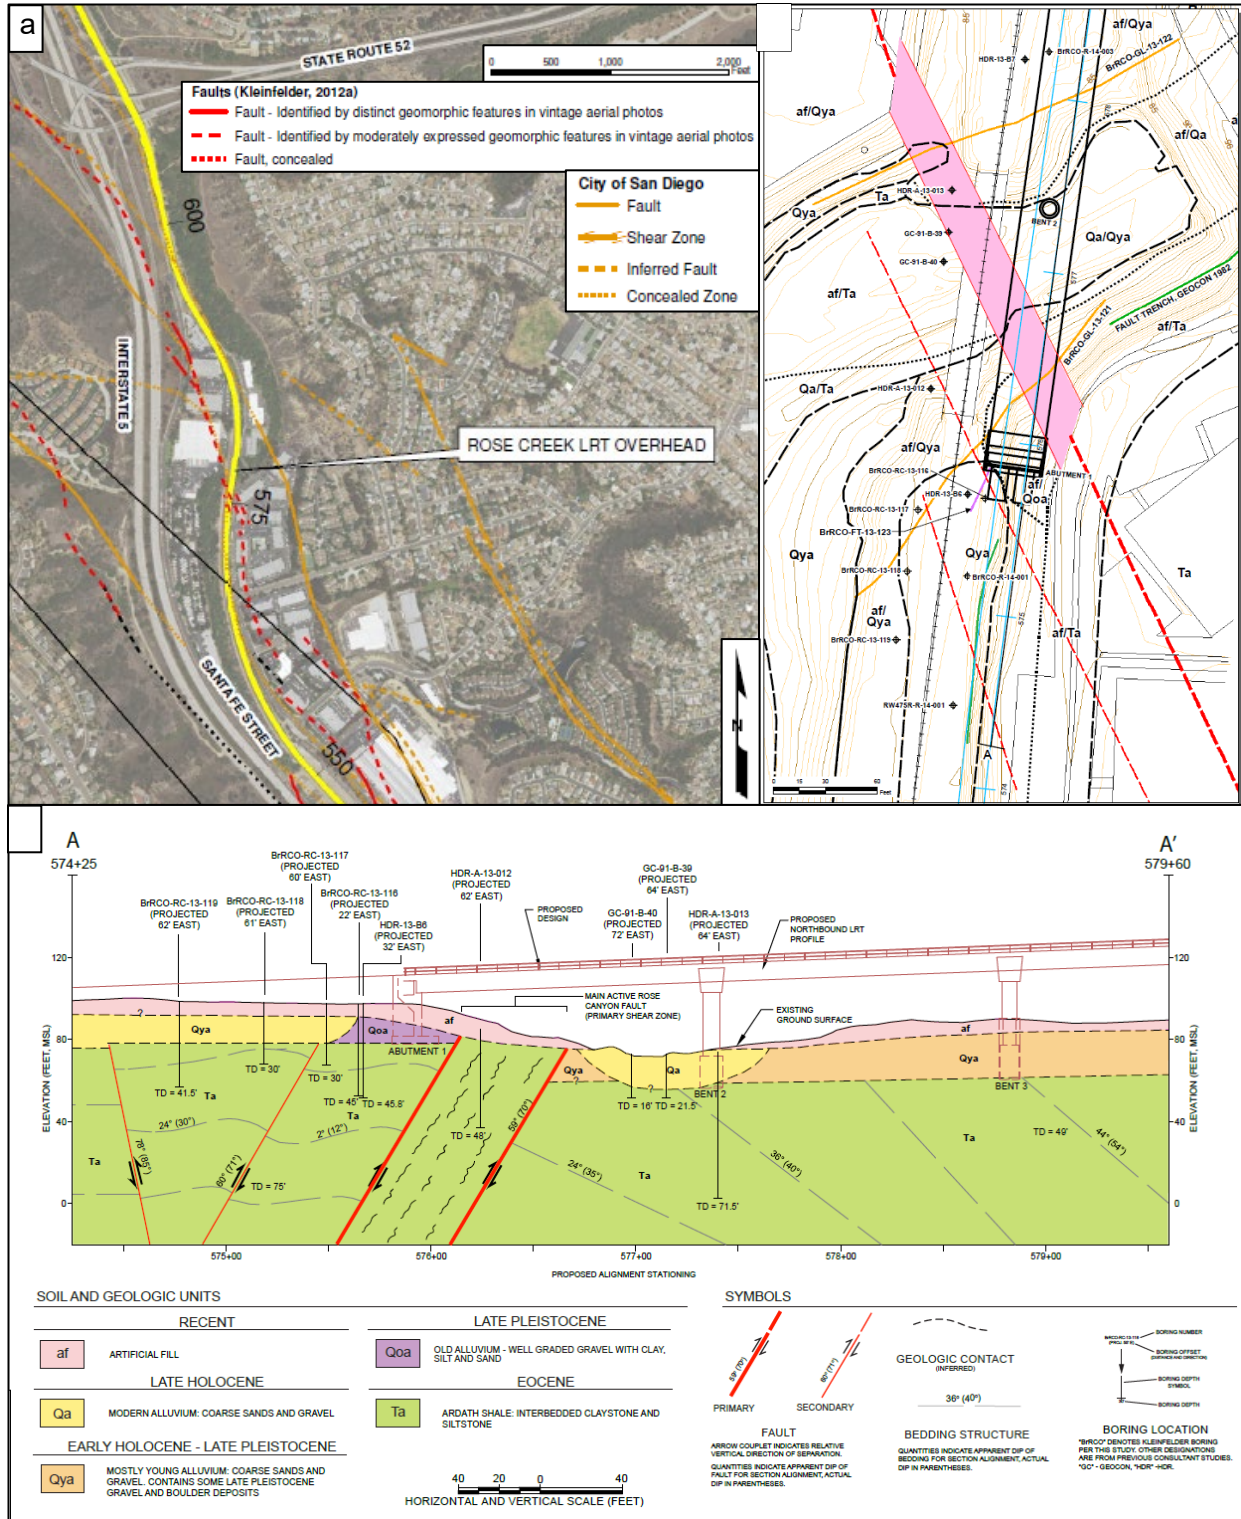
Figure 2. Location map and geologic profile at Locality 1b. a) Index map showing location of Rose Creek LRT Overhead site (modified from Kleinfelder, 2015, Figure 3-6). b) Map depicting location subsurface explorations and Geologic Cross Section A-A' (from from Kleinfelder, 2015, Figure G-3). c) Geologic Cross Section A-A' constructed along trolley line alignment (from Kleinfelder, 2015, Figure G-11).

Kleinfelder's fault investigation of the RCO (Plate 1, Locality 1b; Figure 2) "confirmed the presence of a system of faults closely aligned with that previously identified across the area". In a cut-slope located south of the RCO southern abutment, they found three small faults which vertically displaced Holocene alluvium on the order of 6 inches or less. Their analysis of two geophysical survey lines north of the cut-slope suggested the presence of a significant fault and was supported by stratigraphic discontinuities of geologic units and differences in structure across the zone, as illustrated in Figure 2c.

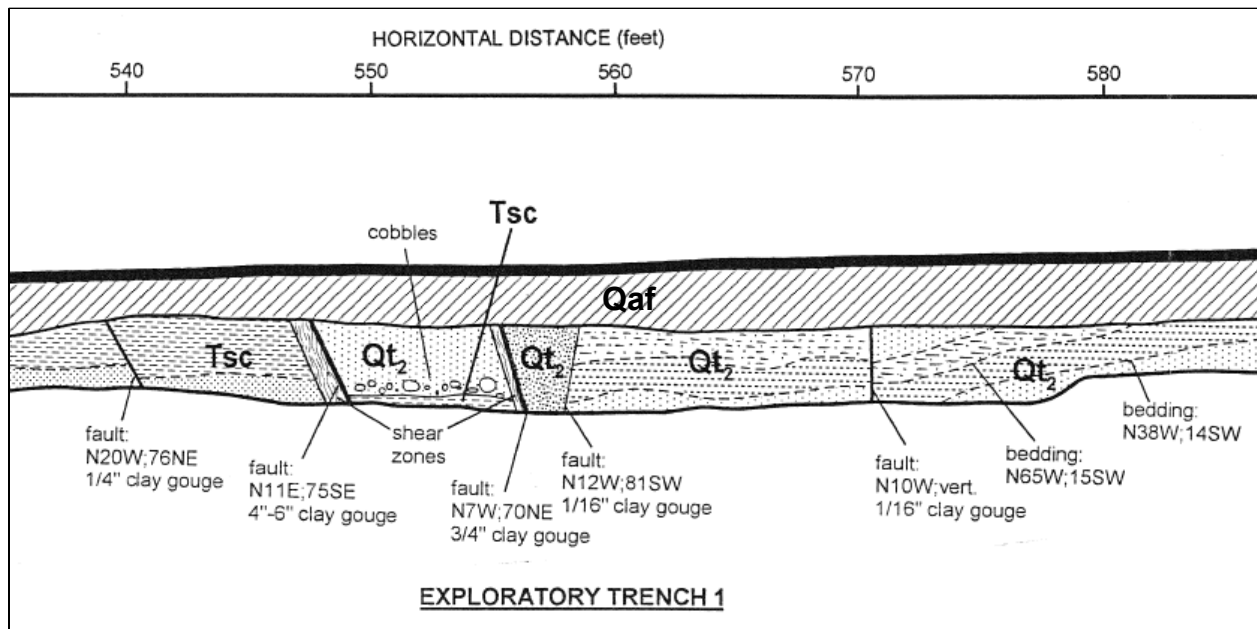
Figure 3. Portion of fault Trench 1 by Robert Prater Associates at Bay View Plaza (Locality 3). Qaf is existing fill; Qt<sub>2</sub> is older terrace deposits; Tsc is Scripps Formation. (modified from Prater, 1998).

East of the main driveway entrance to the site off Clairemont Drive, another zone of faulting was encountered which consisted of two significant shears 5 to 12 inches wide about 6 feet apart and a smaller fault about 2 feet to the east forming a graben structure (Figure 3). The westernmost of the two shear zones included clay gouge up to 6 inches thick. Older terrace deposits (Qt<sub>2</sub>) were faulted against Scripps Formation, and drag folding indicated a significant component of normal separation along with east-side-down apparent vertical separation. No soil or Holocene deposits were encountered across the fault zone. Prater concluded the relative age of faulting was unknown from direct evidence, but it was their opinion the faulting was pre-Holocene based on lack of geomorphic evidence of recent activity and similarity with faulting west of the main entrance.

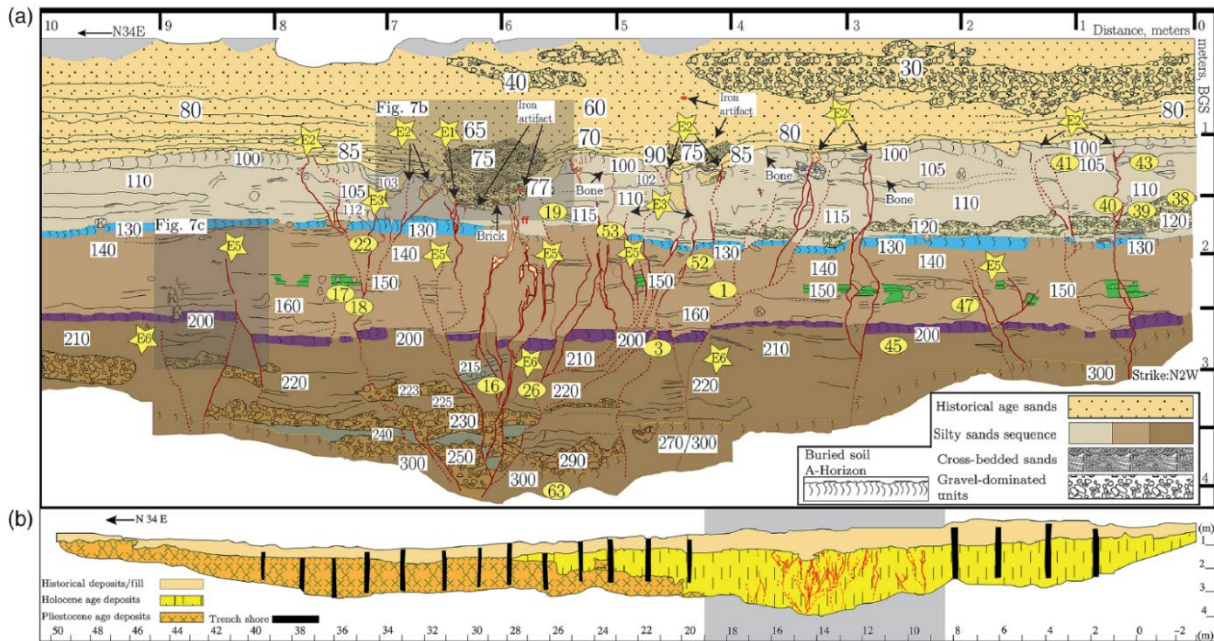
Figure 4. (a) Trench log T2 at the Presidio Hills Golf Course (Locality 5) in Old Town San Diego (from Singleton et al., 2019). Locations of interpreted event horizons are marked as stars. Locations where detrital charcoal was sampled for radiocarbon dating are marked as ovals. Stratigraphic units are marked with white boxes. K, krotovina; ff, fissure-fill. (b) Log of full south face of T2. Shaded area is the location of (a).

Singleton *et al.* (2019) presented results of two paleoseismic trenches excavated across the main trace of the fault at the Presidio Hills Golf Course in Old Town San Diego. The location of the fault was first interpreted from geomorphic features identified on 1927 aerial photographs which indicate right-lateral movement. Trench T-1 encountered a secondary strand of the fault in weakly to massively bedded silt stratigraphy but the trench could not be extended by mechanical equipment toward the presumed main fault strand to the southwest due to the presence of a Spanish colonial-era wall foundation. The authors suggest the main trace of the fault was not encountered in trench T-1 and that it's possible a trace of the fault exists east of T-1 as well. Trench T-2 (Figure 4) exposed three distinct stratigraphic sections interpreted as: 1) post-1850 alluvial fan and fluvial deposits loaded with historical debris; 2) Holocene alluvial fan and fluvial deposits; and 3) Pleistocene alluvial deposits with a well-developed clay-enriched soil.

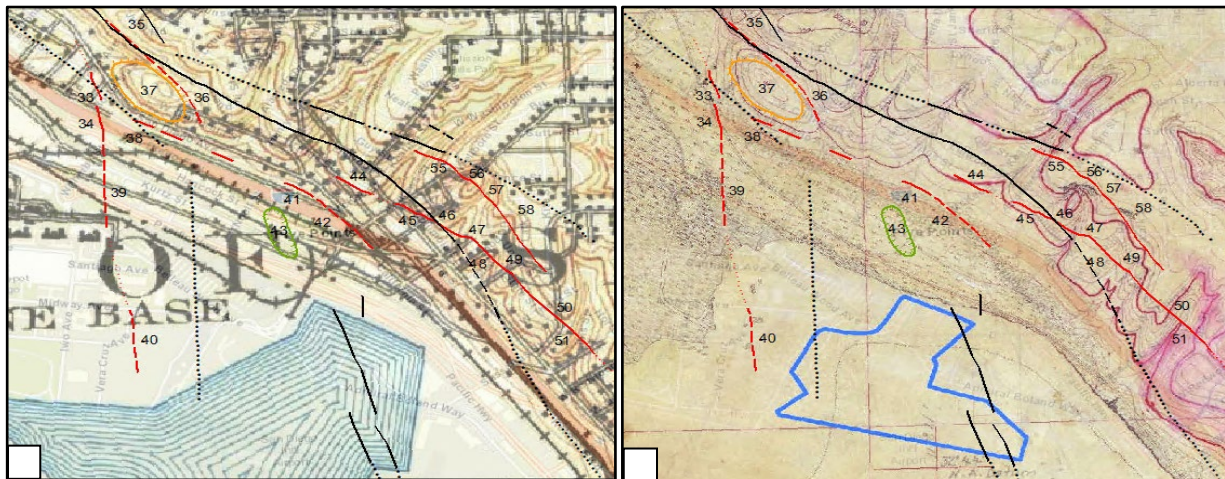
Figure 6. Historic topographic maps depicting a probable fault-related break in slope, saddle, and pressure ridge (numbered 35, 36, and 37, respectively) near Old Town. a) Base map USGS, 1904, San Diego Quadrangle map, 1:62,500-scale. b) Base map from Kleinfelder (2013b) and U.S. Coast Survey, 1851, Map of San Diego Bay, 1:10,000-scale map. Red lines depict fault-related geomorphic features identified by Kleinfelder (SANDAG, 2014) from 1928 aerial photographs. Black lines are faults from USGS and CGS Quaternary fault and fold database (2019). Blue polygon depicts boundary of SDIA North Side study by Kleinfelder (2013b; Locality 15). See Plate 2 and Table 2 for description of geomorphic features.

Review of historic topographic maps (U.S. Coast Survey Office, 1851, and USGS, 1904) for this study revealed the presence of a probable fault-related break in slope, pressure ridge, and ridgeline saddle south of Old Town near the intersection of Congress Street and Hortensia Street (Plate 2, Features 35, 36, and 37). These features are illustrated in Figure 6 and are near a fault exposure observed in a cut-slope at the end of Congress Street described by Treiman (1993), Farrand and Elliot (1979), and Gastil *et al.* (1979). The features also coincide with an interpreted bifurcation of the fault south of Old Town by Kleinfelder (SANDAG, 2014) into strands trending approximately N65W along San Diego Avenue (Plate 2, Features 38, 41, and 42) and N5W toward the Marine Corps Recruit Depot (Plate 2, Features 33, 34, 39 and 40).

As discussed in the Old Town section, Kleinfelder interpreted a bifurcation of the RCFZ and Old Town fault south of Old Town near the intersection of Old Town Avenue and San Diego Avenue, where a topographically higher area interpreted as a pressure ridge is apparent on historic topographic maps (Figure 6 and Plate 2, Feature 37). One strand was interpreted to trend approximately N55-65W and extends for up to 1.5 miles southeast toward downtown San Diego. Kleinfelder interpreted a set of three faults stepping up the west-facing escarpment east of I-5 as part of this strand (Plate 2, Features 38 and 41 through 54). Two of the faults extend southeast of the Washington Street drainage and generally coincide with mapping of the RCFZ by Kennedy *et al.* (1975) and Treiman (1993). Fault studies at Localities 10 and 11 (CTE, 2006 and Applied Earth Technology, 2006, respectively) generally corroborate these faults as interpreted by Kleinfelder (SANDAG, 2014).

| <b>Feature No.</b> | <b>Feature Type*</b> | <b>Evaluation comment</b> |
|---|---|--|
| 36 | Saddle | Apparent saddle indicated on historic topographic maps (see Figure 6; USGS, 1904, San Diego Quadrangle, and U.S. Coast Survey Office, 1851). |

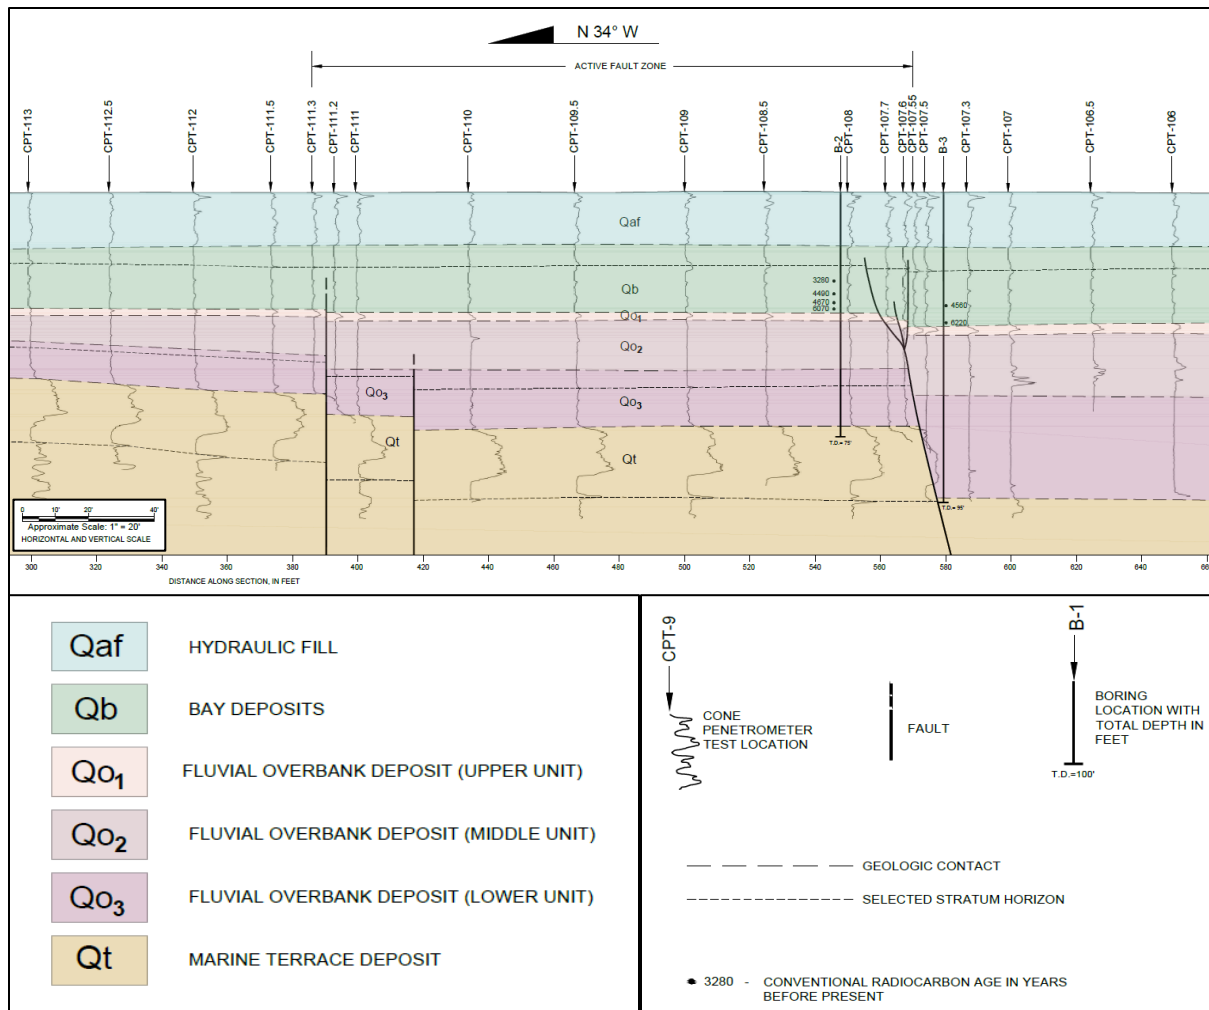
Figure 7. Portion of CPT Profile A from the SDIA Southside Airfields – East Ovals site (Locality 12). The East Bay Fault is shown offsetting mid- to late-Holocene bay deposits. Modified from Kleinfelder (2012a).

The Southside Airfield – East Ovals site (Ovals site) occupies a portion of the southeast side of the airport and consists of aircraft taxiways and large unpaved ovals (Kleinfelder, 2012a). Kleinfelder's evaluation of the Ovals site included 97 CPTs and 4 continuous core borings. Eleven samples of organic sediment and shells were obtained from bay deposits for radiocarbon dating. Their analysis of the CPT profiles revealed a Holocene-active fault located on the west side of the Ovals site which they named the East Bay Fault (Plate 1 and Figure 7).

The East Bay Fault was shown to be comprised of at least four branches, expressed by displaced stratigraphic units across an area up to 130 feet wide, and interpreted to be part of a larger fault which extends through the North Side area (see Locality 15) of SDIA along a northwest orientation. Analysis of CPT profiles indicated that stratigraphic units have vertical separation down on the east side of the fault, and significant lateral displacement along the East Bay Fault was demonstrated by thickness differences in stratigraphic units across the fault zone. The youngest unit reportedly displaced by faulting at the Ovals site was a bay deposit with a minimum age of 2,920 years BP. However, Kleinfelder reported the main branch of the East Bay Fault at the Ovals site extends up through most, if not all of the Holocene bay deposits, and that a radiocarbon age of 430 years BP was obtained from a sample near the top of the bay deposits approximately 1000 feet west of the fault, indicating the most recent faulting is likely as young as 400 years ago. They pointed out this is consistent with the timing of the most recent rupture in La Jolla and downtown San Diego dated around 1650 A.D. (Grant and Rockwell, 2002).

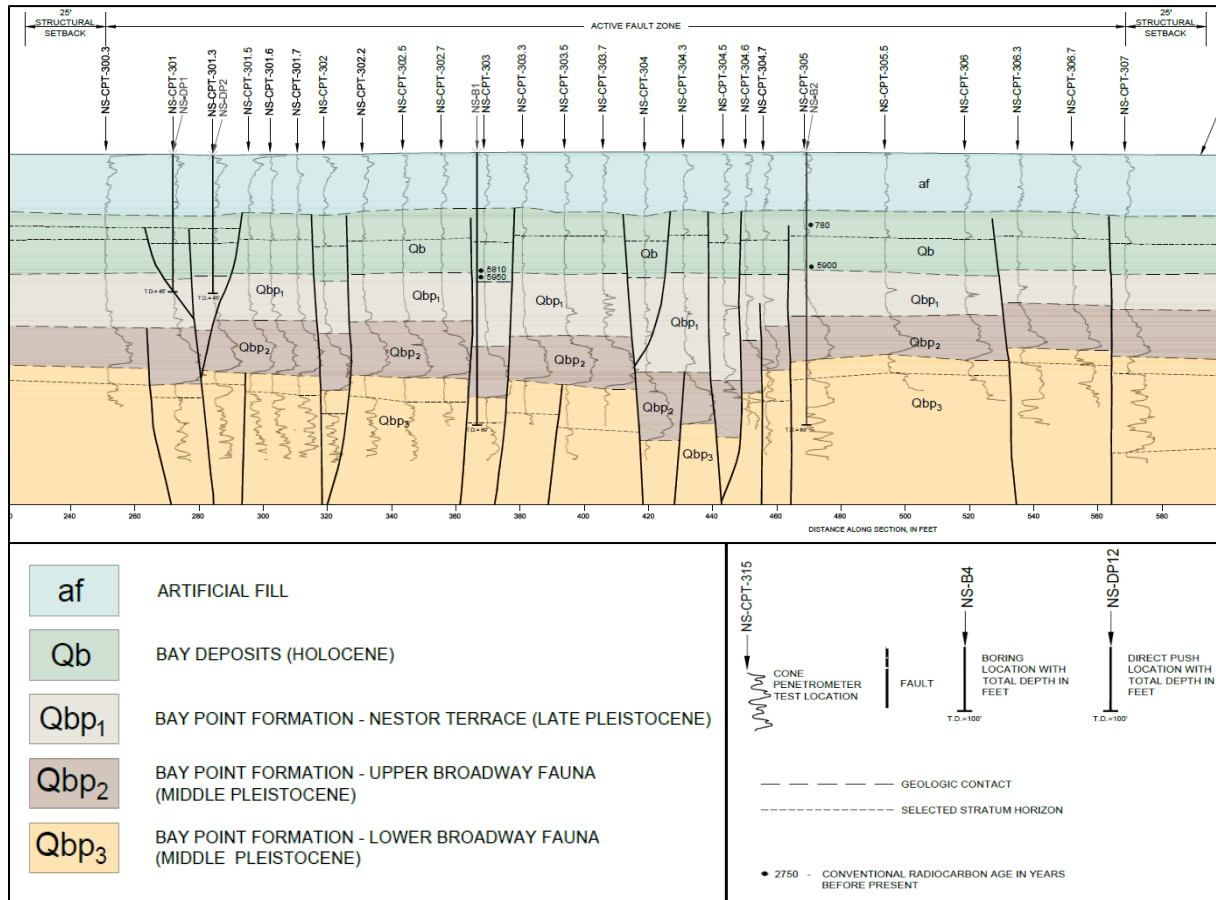
Figure 8. Portion of CPT Profile 300 from the SDIA North Side site (Locality 15). The East Bay Fault Zone is shown offsetting mid- to late-Holocene bay deposits. Holocene-active faults were also interpreted to extend to the pre-fill bay bottom surface producing scarps and suggesting fault displacement within the past several hundred years. Modified from Kleinfelder (2013b).

Across the North Side site, Kleinfelder’s analysis indicated the East Bay Fault Zone is comprised of an anastomosing band of discontinuous faults trending approximately N20W, and that stratigraphic units have vertical separation down on the west side of the fault. Near the southern portion of the site, the fault zone is about 200 to 240 feet wide and appeared to comprise at least 10 to 14 Holocene-active fault splays that either terminated at the bottom of the bay deposits or penetrated into them (Figure 8), juxtaposing Holocene bay deposits against the late Pleistocene Nestor Terrace unit. The width of the East Bay Fault Zone narrows to approximately 50 feet as it crosses the RCC, and further narrows to a width of approximately 10 feet at the northern boundary of the North Side site.

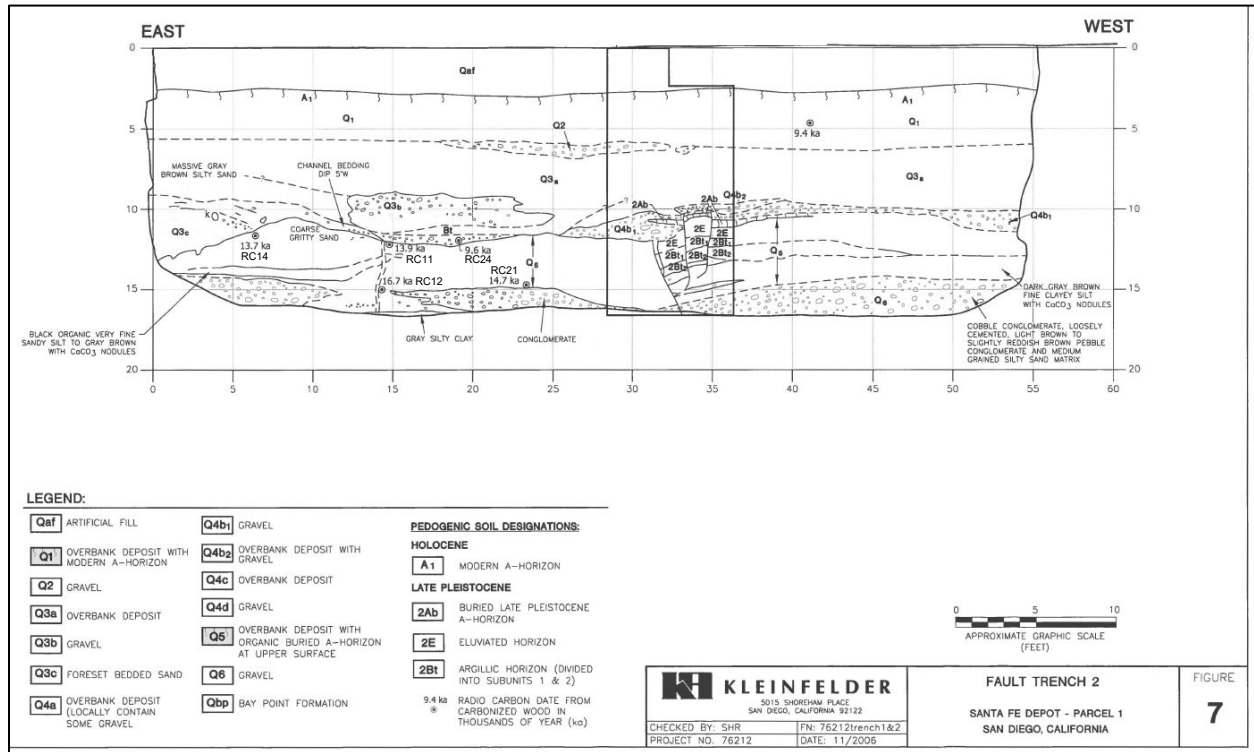
Figure 9. Log of Fault Trench 2 by Kleinfelder (2007a) at Santa Fe Depot Parcel 1 (Locality 27). Radiocarbon dating demonstrates faulting on the PCH Fault between 9.6 and 13.7 ka.

We evaluated the most recent fault activity by updating the radiocarbon analysis with more recent calibration curves (Reimer *et al.*, 2020) and standard Oxcal chronological modeling (Bronk-Ramsey, 1994) (Figure 12). The age of the most recent faulting was constrained the best in trench T2 (Figure 9) and is bracketed between samples RC24 and RC14. This results in a possible age of faulting ranging from 10.3 to 13.4 ka. In trench T3 a similar age can be interpreted. Regardless of which chronologic model is used, the timing of the most recent earthquake at Locality 27 is latest Pleistocene to early Holocene in age and classifies the fault as Holocene-active based on the current definition for an active fault as one which has moved within the last 11,700 years.

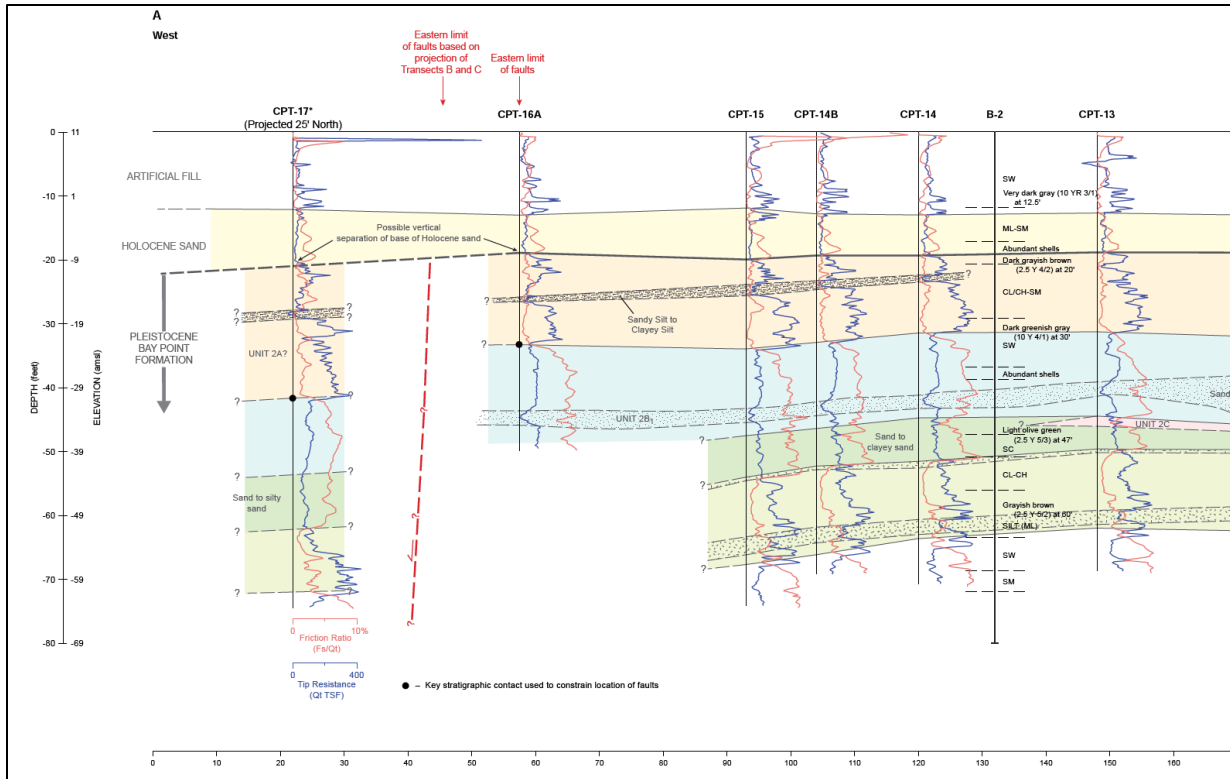
Figure 10. Portion of Geologic Cross Section A-A' by William Lettis & Associates, Inc. (WLA, 2008a) at the Old Police Headquarters (Locality 29). The fault appears to offset the base of the Holocene alluvium by 2 feet. WLA suggested the zone of faulting may be associated with the offshore Coronado Fault to the south and/or the PCH Fault to the north.

- Faults appear to offset uppermost Pleistocene Bay Point Formation in all geologic cross sections and appear to offset the base of Holocene alluvium by two feet in Geologic Section A-A' (Figure 10).
- No unfaulted strata of pre-Holocene age can be used to preclude Holocene slip.
- The Holocene-active Coronado Fault projects onshore near the western margin of the site, and the zone of faulting identified in this study may be associated with the Coronado Fault.

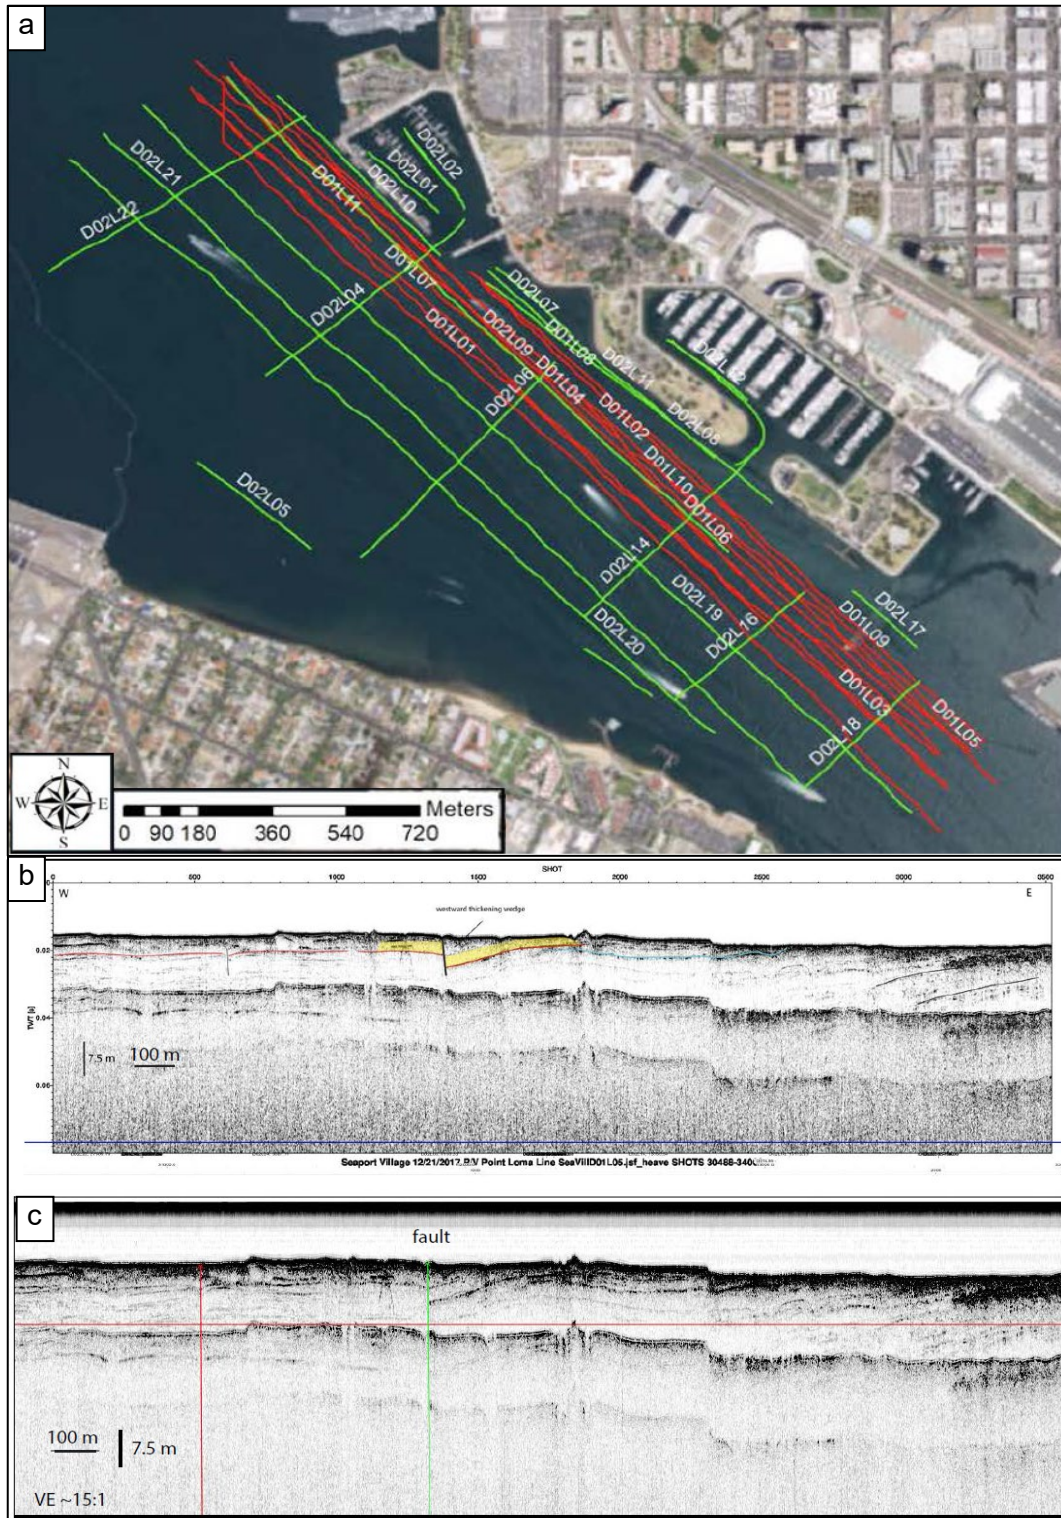
Figure 11. Seaport Village (Locality 30) CHIRP Seismic Survey by Environment and Marine Solutions. a) Shiptrack map for the geophysical survey. Red lines acquired on day 1; green lines acquired on day 2; line numbers labelled. b) CHIRP line D01L05 (low gain) showing western dipping stratigraphy (yellow) bound by the Coronado Fault (black line). c) CHIRP line D01L05 (high gain): green line is the main fault; red vertical line is a small secondary fault. Modified from Ninyo & Moore, 2018, Appendix B, Figures 3a and 5.

Ninyo and Moore and Environment and Marine Solutions also interpreted two roughly parallel fault structures from bay floor stratigraphic offsets within several of the CHIRP seismic lines performed as part of the offshore geophysical survey (Figure 11). The offsets were interpreted as being associated with folding/faulting within San Diego Bay. One fold/fault structure trends N40E and is located within the northwestern portion of the offshore study area southwest of the docks for Tuna Harbor. However, based on interpretation of CHIRP seismic lines performed in between the boat docks, the fold/fault is interpreted as having a northeast termination point that does not extend into Tuna Harbor or on to the adjacent shoreline.

- Correlates well with faulting identified by the onshore subsurface exploration program.
- Interpreted as having an orientation of approximately N9E.
- Continuous with the fault zone interpreted from onshore geologic cross sections.
- Interpreted as being a near vertical structure with no observed splays.
- Characterized by westward dipping reflectors bounded by a near-vertical fault with ~4 to 4.5 m of throw.
- Offsets are observed within the shallow bay floor sediments and interpreted as occurring within Holocene bay deposits.
- Observed offset likely records 2 to 4 events.

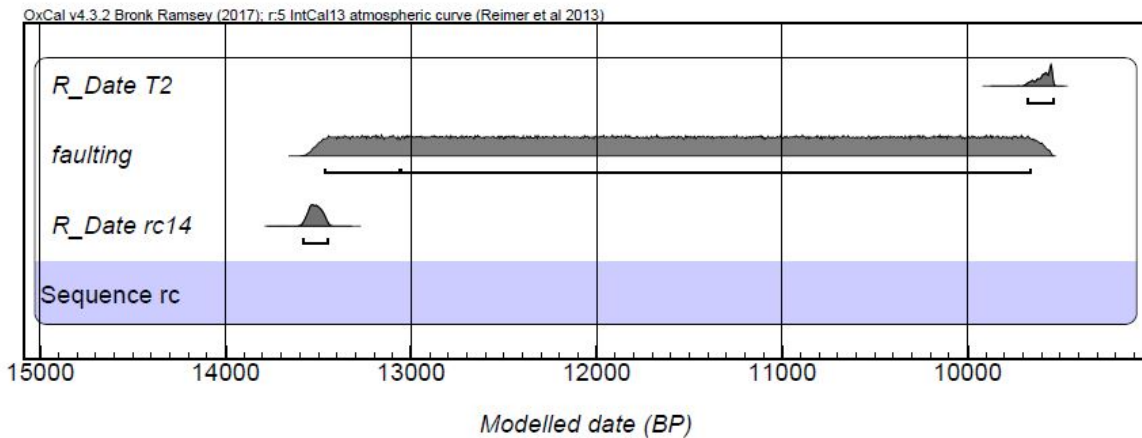
Figure 12. Oxcal chronological model (CGS, this study) of Radiocarbon data collected from Locality 27, Santa Fe Depot Parcel 1, indicating a range of faulting from 10.3 to 13.4 ka for the PCH Fault.

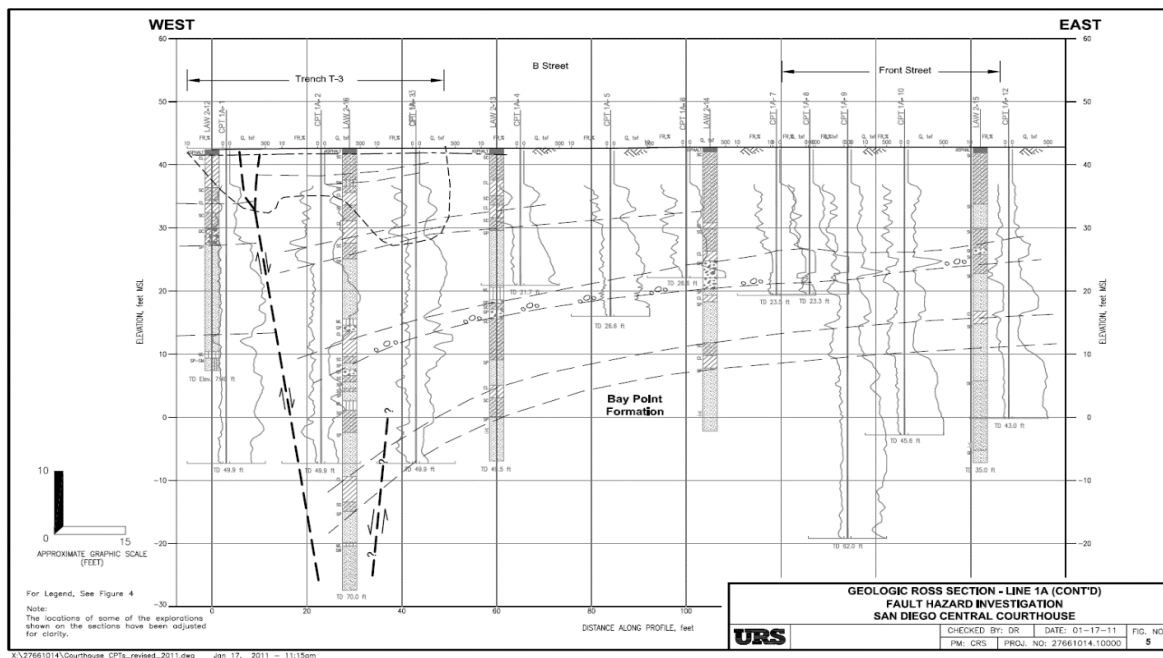
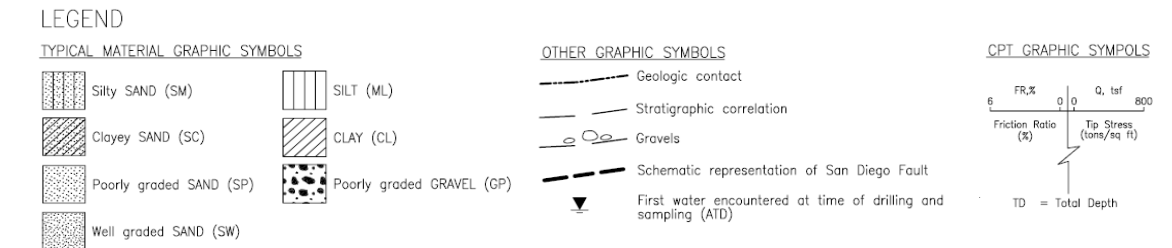
Figure 13. Portion of Geologic Cross Section Line 1A by URS (2011a) for the San Diego Central Courthouse (Locality 34), which suggests stratigraphic anomalies due to faulting with down to the east vertical separation. The location of trench T-3 is depicted in the upper left portion of the cross section.

The explorations encountered fill, Holocene alluvium, and Quaternary-age Bay Point Formation (old paralic deposits). URS developed geologic cross sections based on the subsurface data, which revealed stratigraphic anomalies suggesting a fault with down-to-the-east separation (Figure 13).

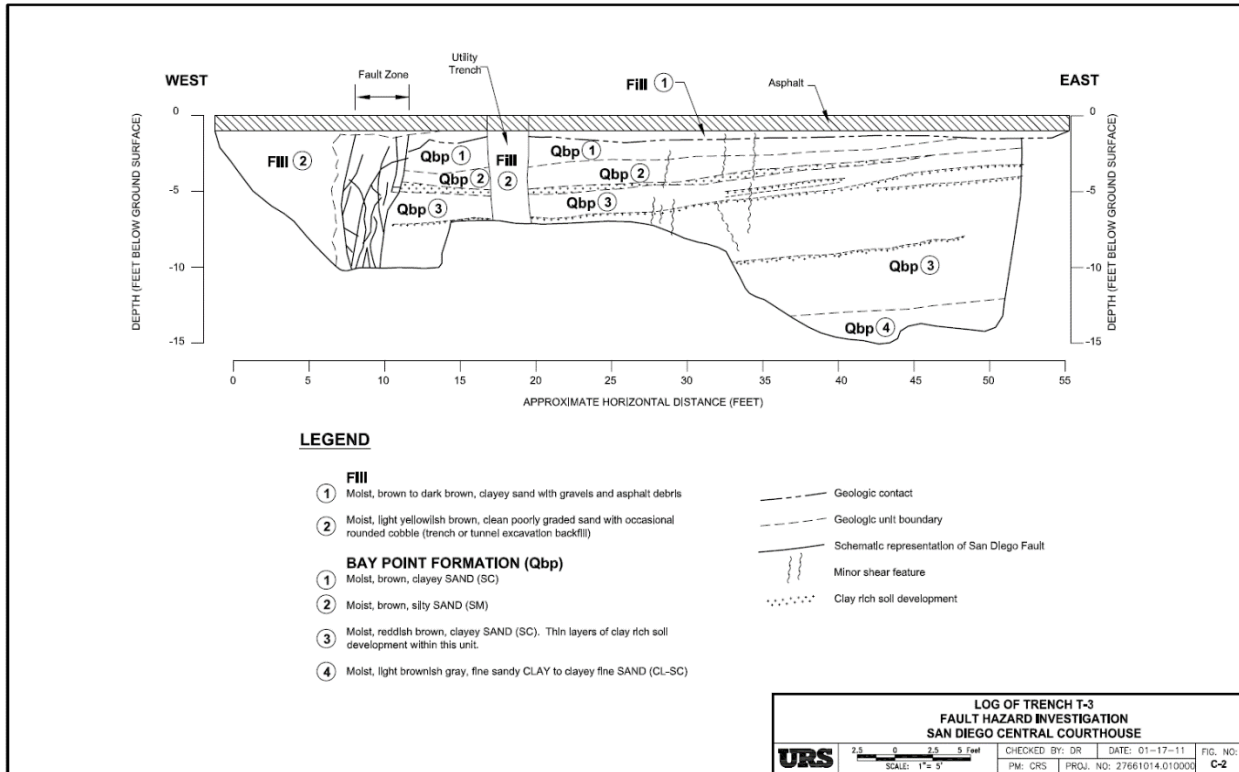
Figure 14. Log of Trench T-3 by URS (2011a) for the San Diego Central Courthouse (Locality 34). See Figure 13 for the location of trench T-3. The fault zone exposed in the trench was interpreted to be the northern projection of the Holocene-active San Diego Fault.

Additionally, trench T-3 (Figure 14) encountered the San Diego Fault, which consisted of an approximately 5-foot wide zone with several pronounced steeply dipping fault planes or shears juxtaposing dissimilar geologic units of Bay Point Formation. They suggested the entire width of the fault zone may not have been captured by the trench due to the presence of backfill materials from an existing tunnel excavation.

URS concluded that near-surface faulting observed in trench T-3 appeared to have occurred along a projection of the mapped location of the Holocene-active San Diego Fault, just south of the site, and recommended the fault be considered active.
